Manhole Inspection Summary

Manhole # S21I__015MH

Insp Date: **9/21/07 10:08 AM**

Location Address: **35 ADDISON ST**

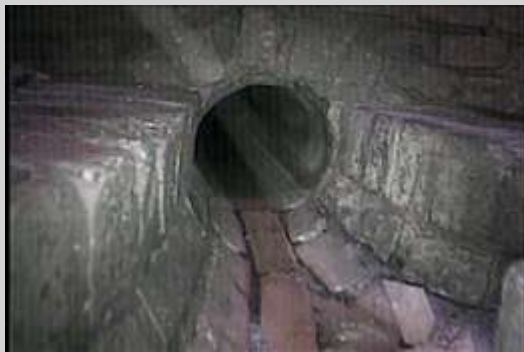
12 O'Clock Outflow

8 in. Circular Gravity Sewer
Pipe Out @ 12 O'Clock

Pipe Height: **7.2** (in.) Rod and Bar (Angled)
Pipe Material: **Clay** ☐ Pipe Lined
Invert Depth: **10.04** (ft.) Flow Characteristics: **None**
Deposits: ☒ None ☐ Mud ☐ Sludge ☐ Debris ☐ Grease
Silt Depth: (in.) Deposits Extent:
Infiltration: **None** Pipe Seal Cond: **Sound**

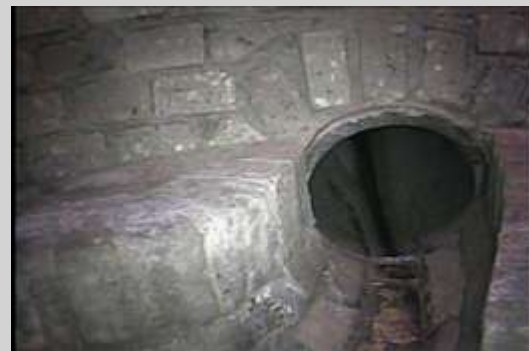
Drop In @ 3 O'Clock

Drop: **Outside** Rod and Bar
Angled: **Yes** Reading: **8.66** (ft.)
Inv Depth: **9.66** (ft.)

Drop Condition: **Open**

Connects To: **Dead End**

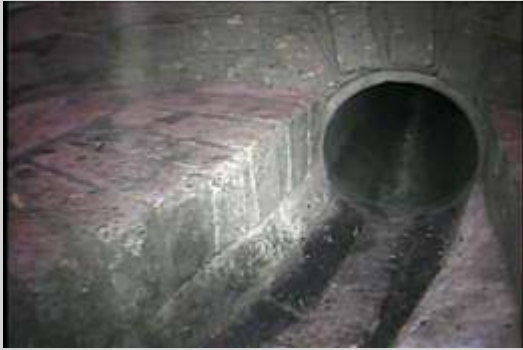
6 O'Clock Inflow

8 in. Circular Gravity Sewer
Pipe In @ 6 O'Clock

Pipe Height: **7.2** (in.) Rod and Bar (Angled)

Infiltration: **None** Pipe Seal Cond: **Sound**
